Case Study of a Watershed Rehabilitation Project: Alkali Creek, Colorado

Burchard H. Heede

USDA Forest Service
Research Paper RM-189
June 1977

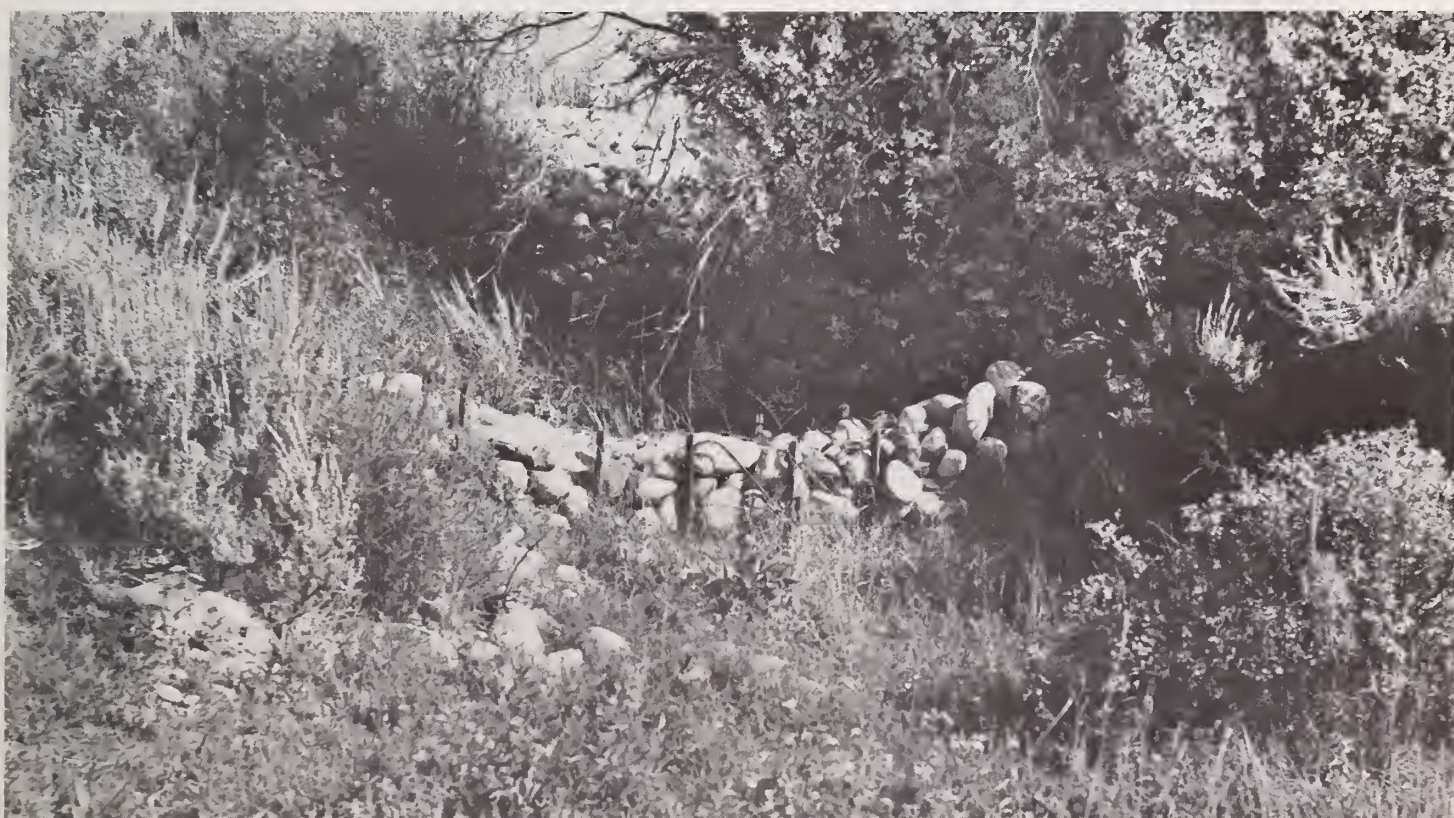
Figure 15.—Upstream view of a double-fence check dam, 14 yr after construction. The apron, as well as the bank protection works, is nearly fully overgrown by herbaceous vegetation and brush.
